National Highway Traffic Safety Administration

ON-SITE AIR BAG INVESTIGATION

CASE NO. - 96-12 FLEET - PRIVATE VEHICLE LOCATION - NORTH CAROLINA ACCIDENT DATE - 1996

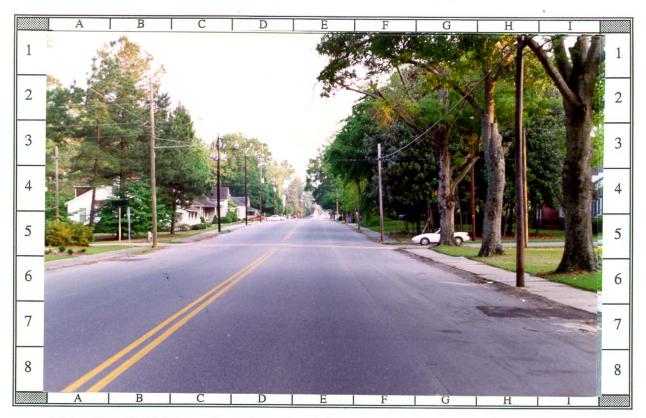
01: Case Vehicle's southward travel path in southbound lane approximately 30 meters (98 feet) north of impact in intersection

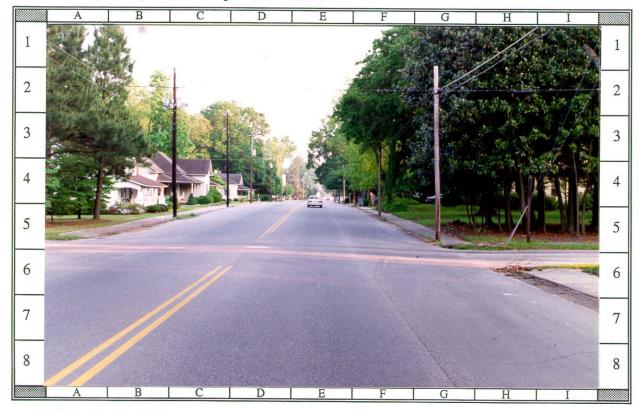
02: Case Vehicle's southward travel path in southbound lane approximately 15 meters (49 feet) north of impact in intersection

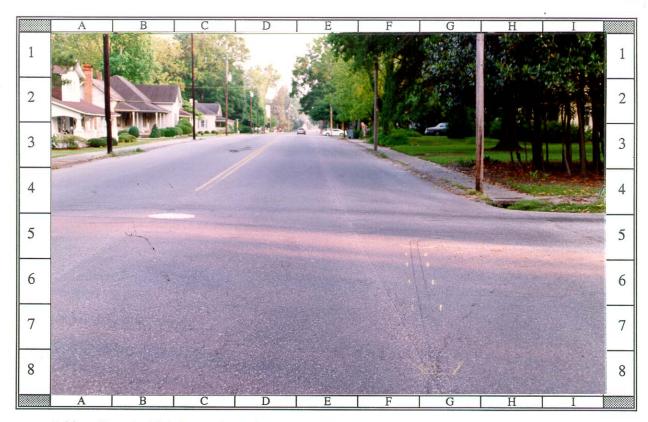
03: Case Vehicle's southward travel path in southbound lane approximately 5 meters (16 feet) north of impact; NOTE: right front skidmark

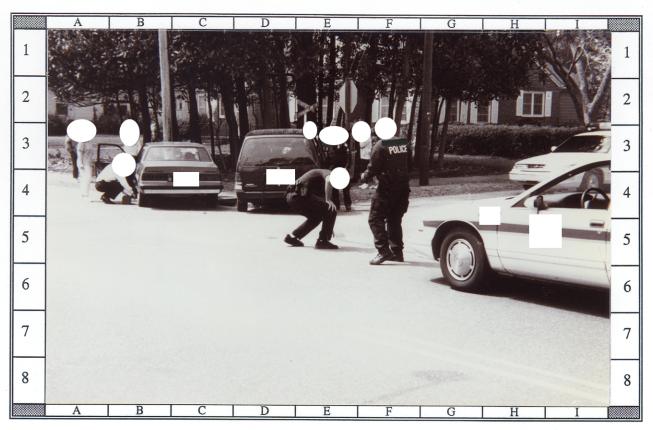
05: On-scene view looking south-southwest showing both vehicles at final rest; NOTE: police officers are marking case vehicle's deflection point

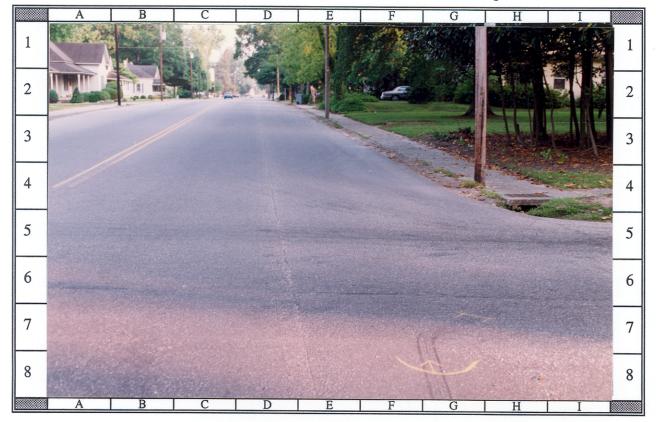
06: Case Vehicle's southbound travel path at points of impact and maximum engagement with Vehicle #2; NOTE: case vehicle's deflection scuff

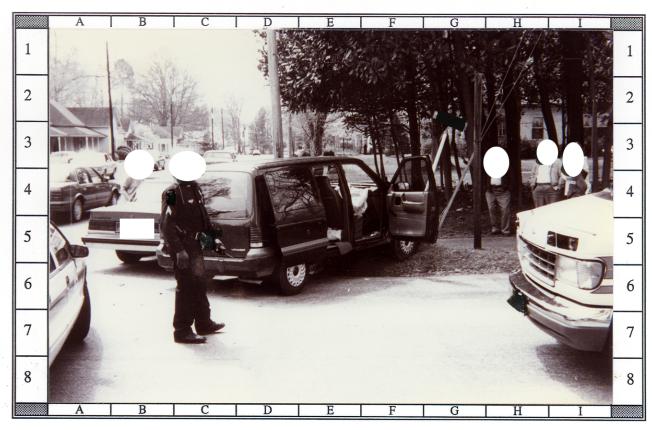
07: On-scene view looking south at case vehicle's final rest position against street sign post; NOTE: post had not been replaced at time of our scene inspection

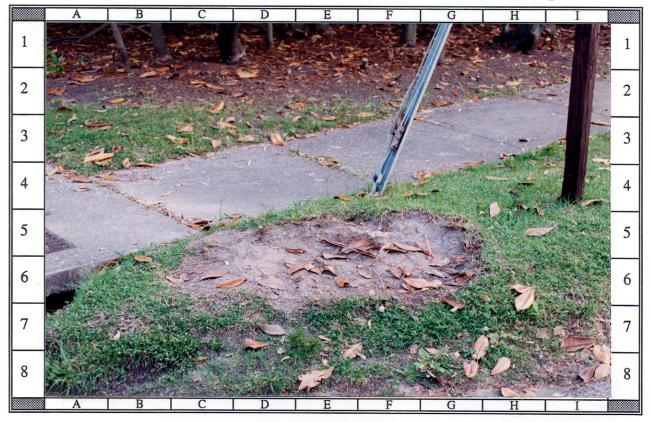
08: Southwest view of Case Vehicle's final rest position; NOTE: Case Vehicle's air dam scraped ground and bumper impacted sign post before coming to rest

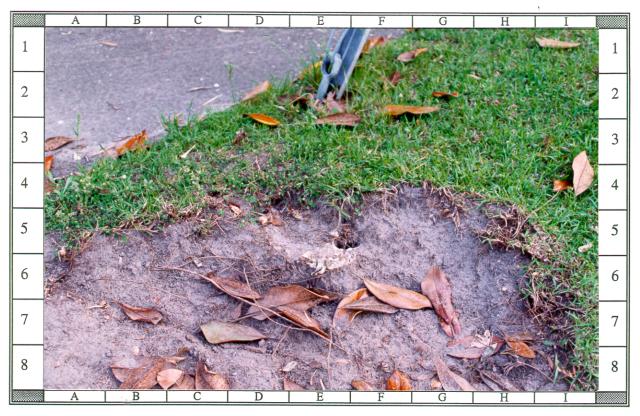
09: Close-up of southwest corner of intersection showing ground and cement base of sign post struck by Case Vehicle's front

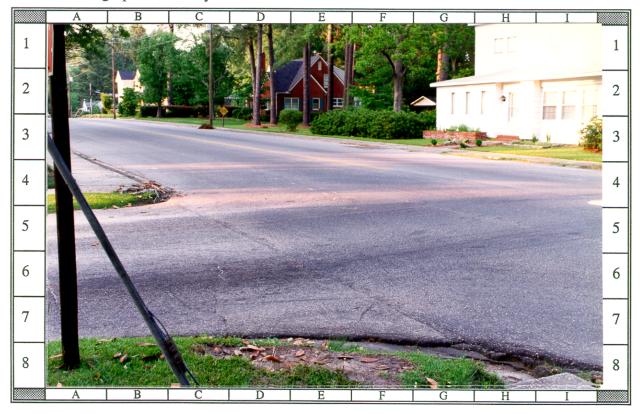
10: Northeastward view of Case Vehicle's southwest travel path taken from beyond final rest area showing area of impact with Vehicle #2

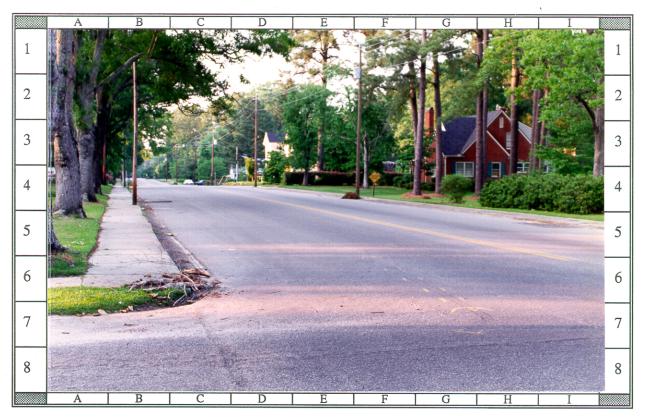
11: North-northeastward view of Case Vehicle's southbound travel path from just beyond area of impact; NOTE: skidmark and deflection point in intersection

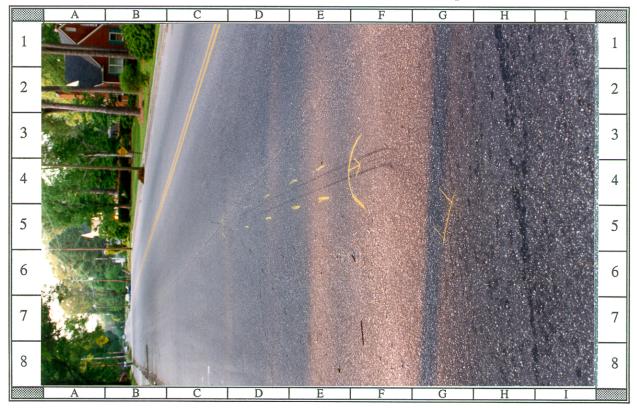
12: Northward close-up of skidmark and deflection point deposited by Case Vehicle's right front tire

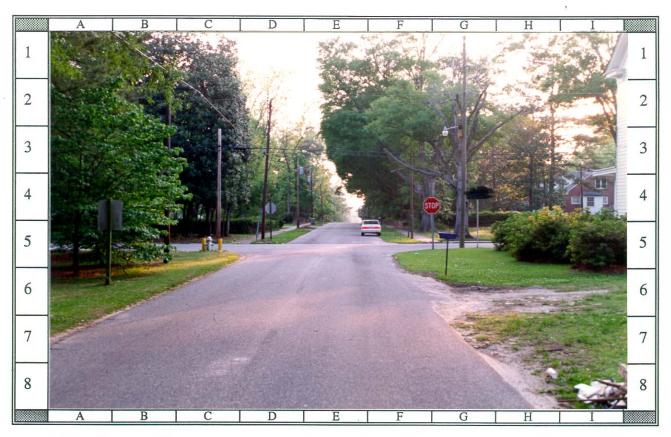
13: Vehicle #2's westward travel path in westbound lane approximately 30 meters (98 feet) east of impact in intersection

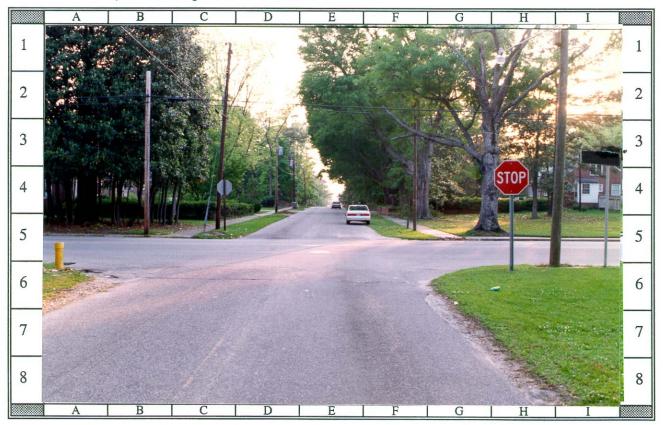
14: Vehicle #2's westward travel path in westbound lane approximately 15 meters (49 feet) east of impact in intersection

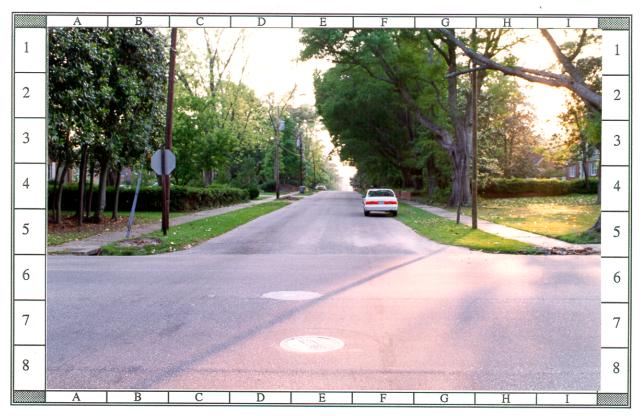
15: Vehicle #2's westward travel path in westbound lane approximately 5 meters (16 feet) east of impact in intersection with Case Vehicle

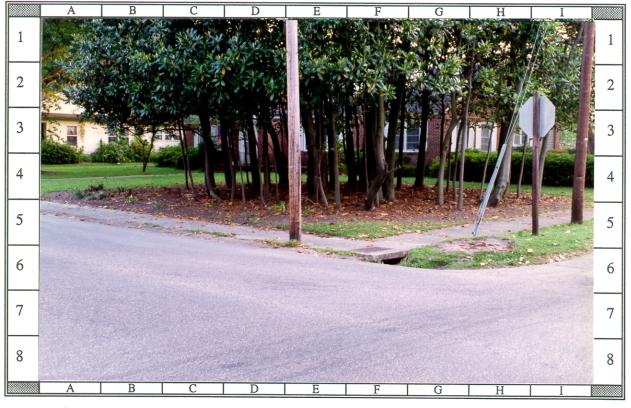
16: Vehicle #2's southwestward travel path post-impact with Case Vehicle; NOTE: Vehicle #2 subsequently struck utility pole on southwest corner of intersection

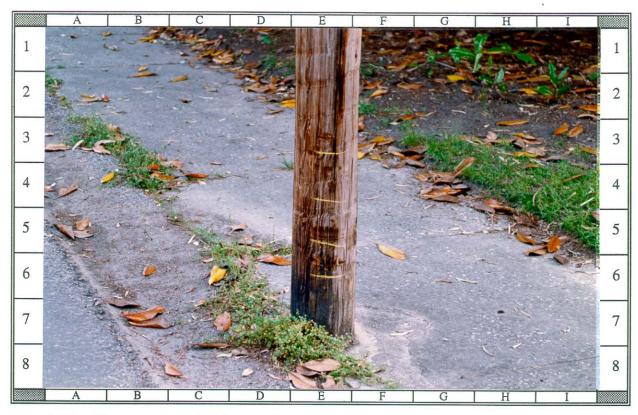
17: Close-up view, looking southwestward, of utility pole on southwest corner of intersection struck by Vehicle #2

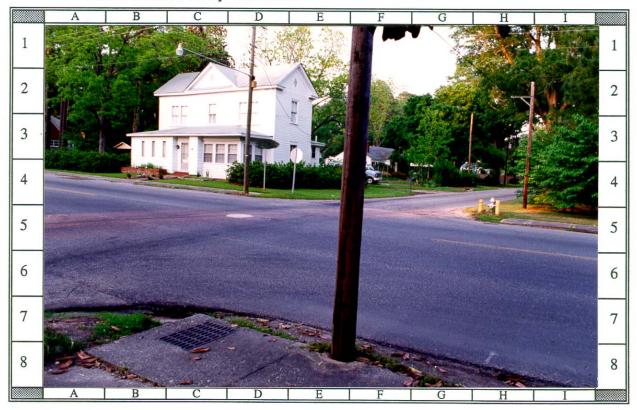
18: Northeastward view of Vehicle #2's post-impact trajectory taken from beyond final rest showing Vehicle #2's final rest position against utility pole

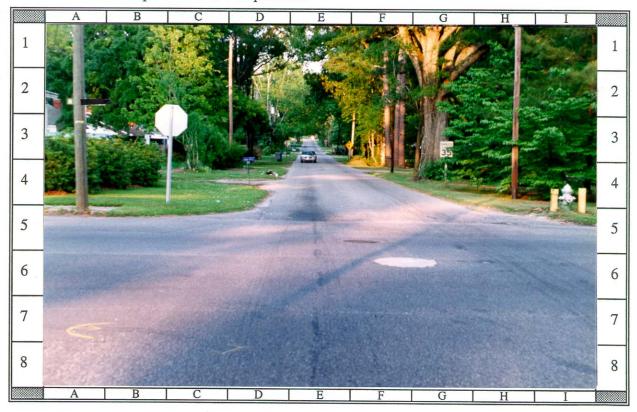
20: Eastward view of Vehicle #2's westward travel path from just beyond area of impact; NOTE: Case Vehicle's deflection mark in foreground

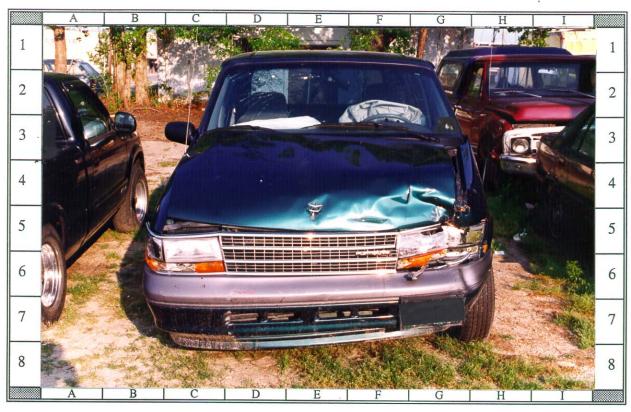
21: Case Vehicle's damaged front without contour gauge present; NOTE: shifting of front bumper to right

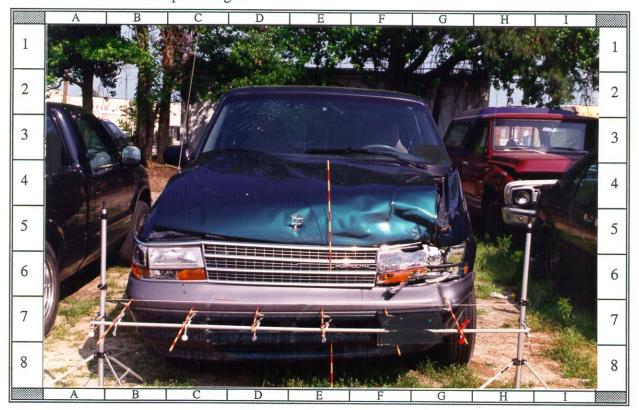
22: Case Vehicle's damaged front with contour gauge present; NOTE: direct damage extends across entire front

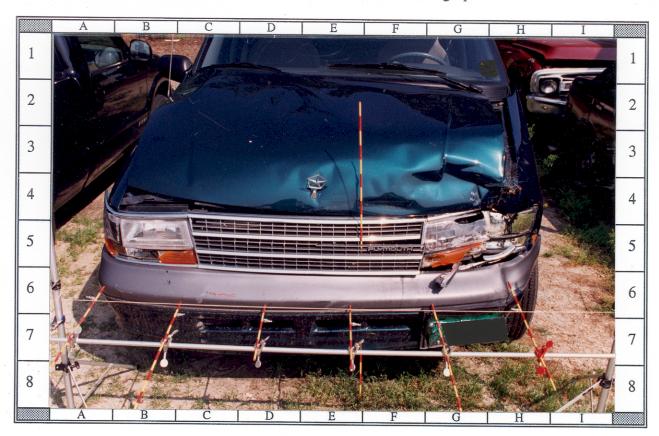
23: Close-up of Case Vehicle's front damage with contour gauge present; NOTE: sign post damage to bumper (cells C6--C7)

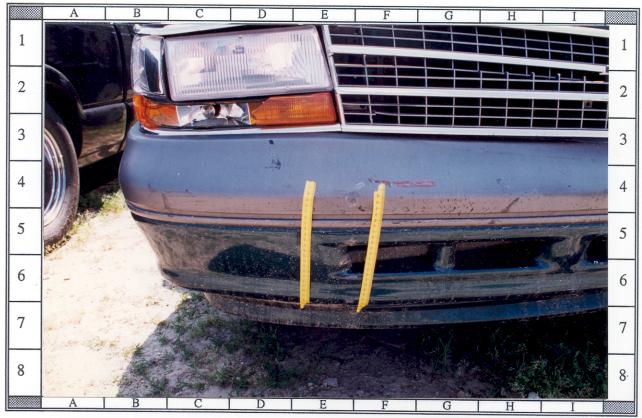
24: Close-up of sign post impact to Case Vehicle's front bumper; NOTE: reddish scuff is most likely from 1986 Chevrolet Celebrity

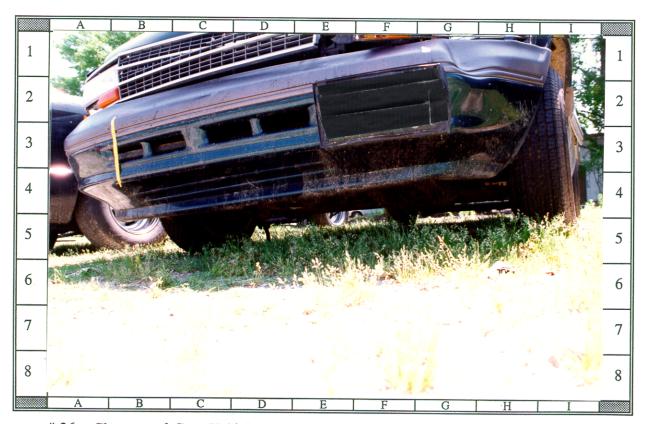
26: Close-up of Case Vehicle's air dam which contacted ground just prior to Case Vehicle's impact against sign post

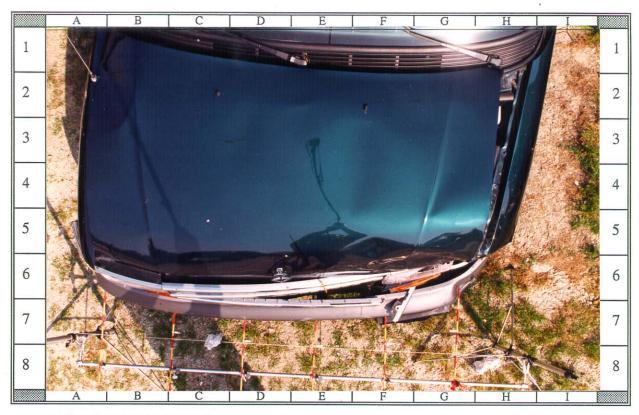
27: Overhead view of to Case Vehicle's frontal damage; NOTE: contour gauge shows damage profile

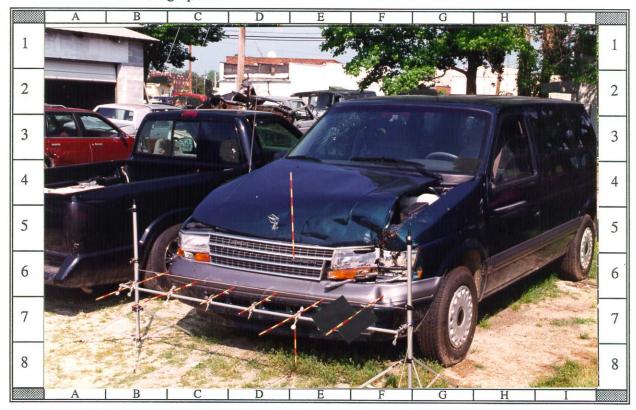
28: Case Vehicle's damaged front viewed from approximately 45 degrees left of front with contour gauge present

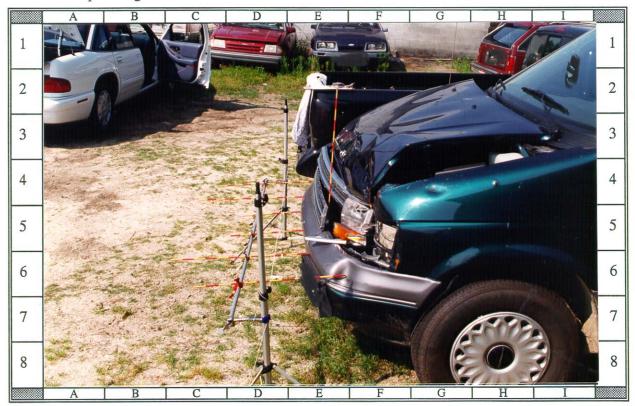
30: Reference line view of Case Vehicle's damaged front from left with contour gauge present

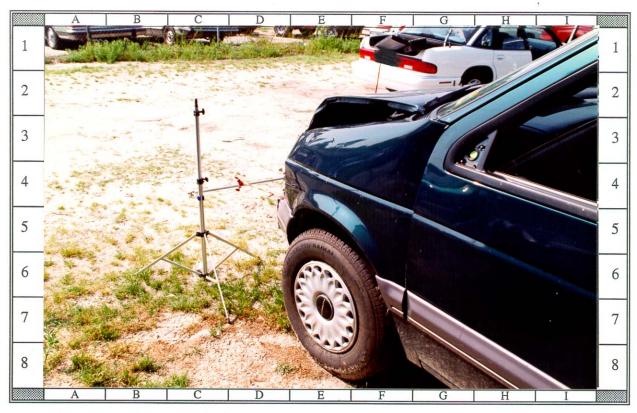
31: Case Vehicle's left fender, viewed from ~ 45 degrees left of back, showing induced damage and shifting which caused left front tire restriction

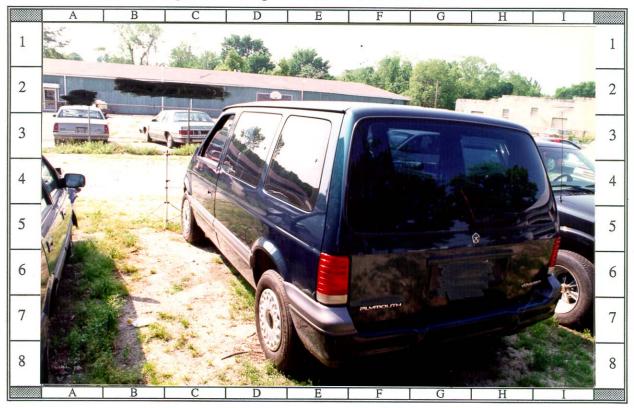
32: Case Vehicle's undamaged left side (except fender) and back viewed from approximately 30 degrees left of back

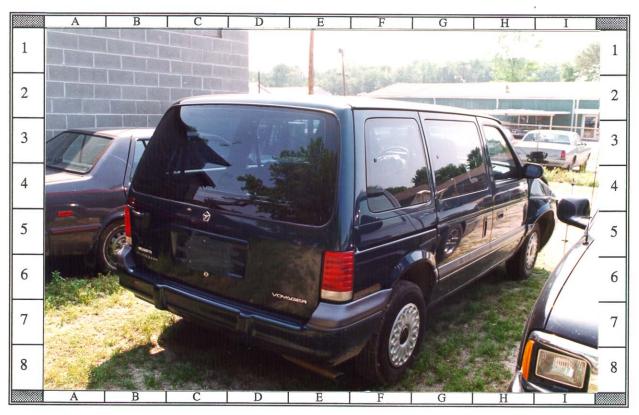
33: Case Vehicle's undamaged right side (except fender) and back viewed from approximately 30 degrees right of back

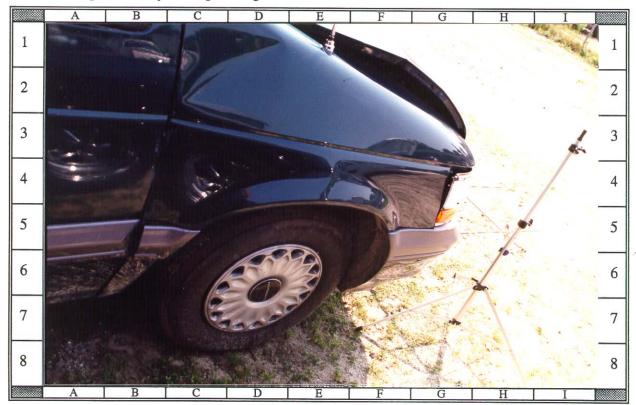
34: Case Vehicle's right fender, viewed from ~ 60 degrees right of back, showing induced damage from bumper shift which caused right front tire restriction

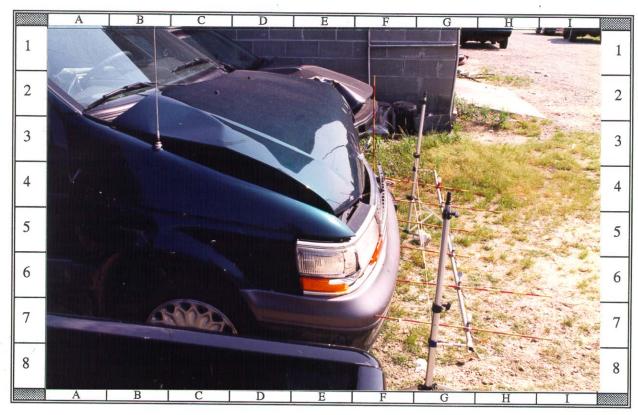
35: Reference line view of Case Vehicle's damaged front from right with contour gauge present

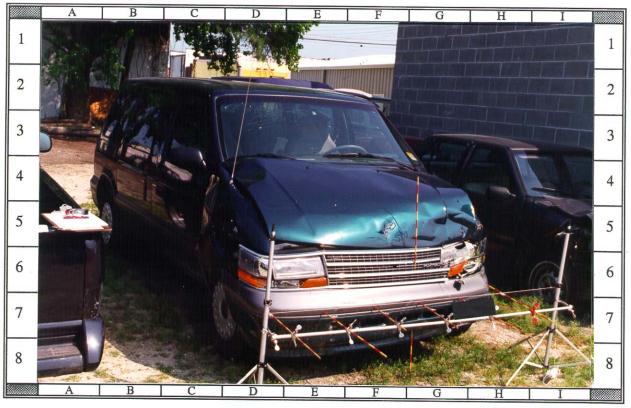
36: Case Vehicle's damaged front viewed from approximately 30 degrees right of front with contour gauge present

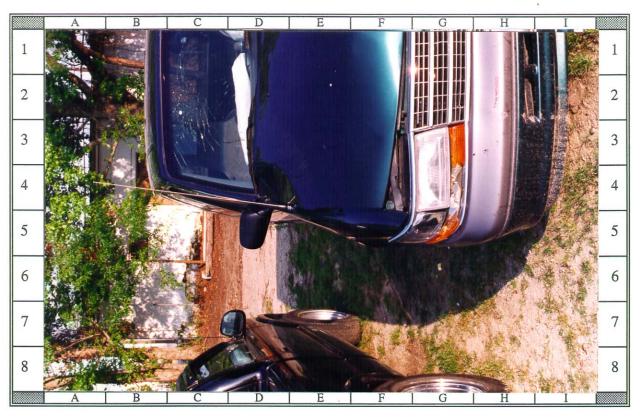
37: Reference line view of Case Vehicle's right side from front showing front bumper's slight rightward shift

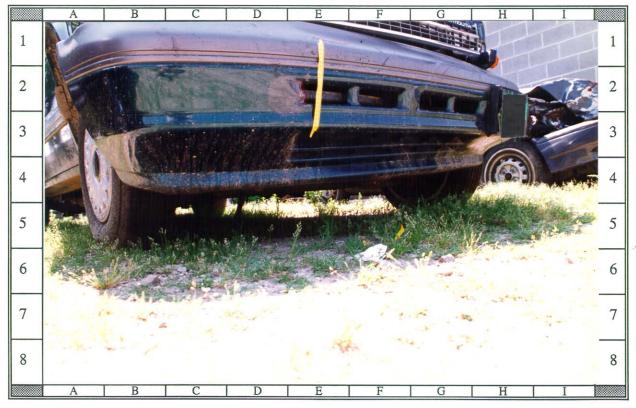
38: Ground level view of Case Vehicle's air dam, from approximately 15 degrees right of front, which contacted ground prior to sign pole impact

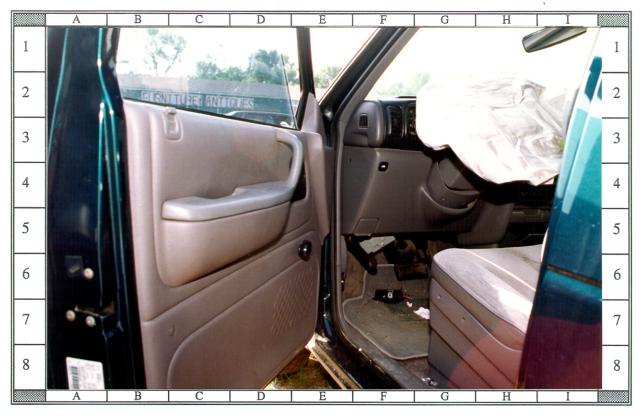
39: Interior surface of Case Vehicle's driver door panel and deployed driver's side air bag and knee bolster viewed from outside driver's door

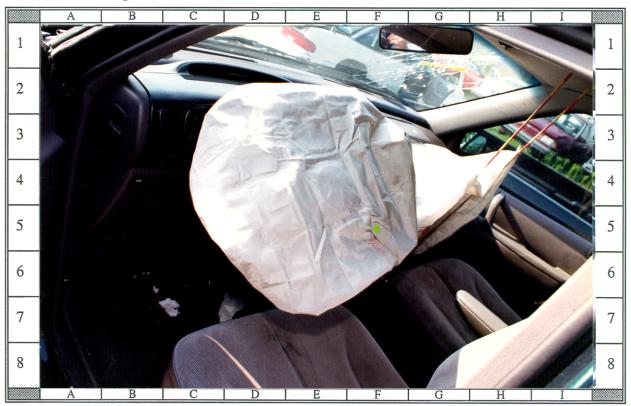
40: Case Vehicle's front seating area and deployed air bags showing contact to driver's air bag; NOTE: lipstick mark on driver's air bag (green dot)

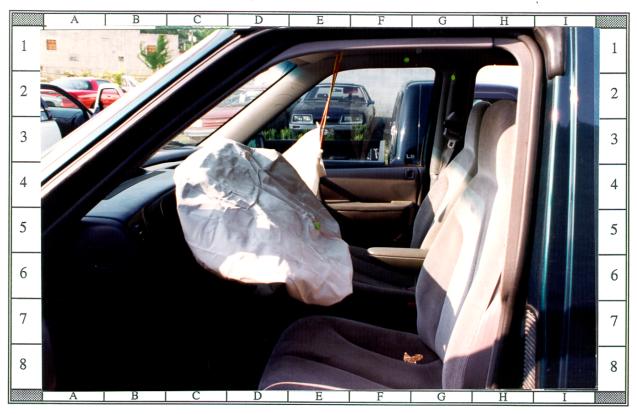
41: Case Vehicle's front seating area and deployed air bags; NOTE: right front passenger contacts to right roof side rail and right "B"-pillar (green dots)

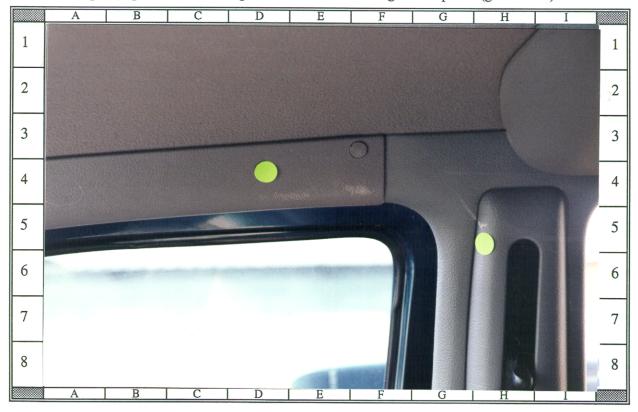
42: Close-up of contacts to Case Vehicle's right side roof rail and "B"-pillar from right front passenger's head

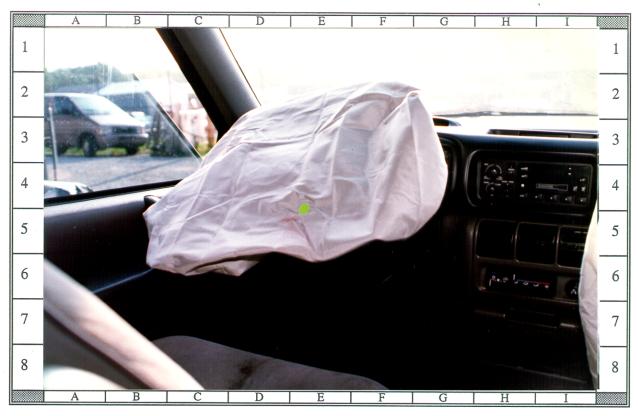
43: Case Vehicle's contacted driver side air bag, center dash, and noncontacted knee bolster viewed from rear center seat

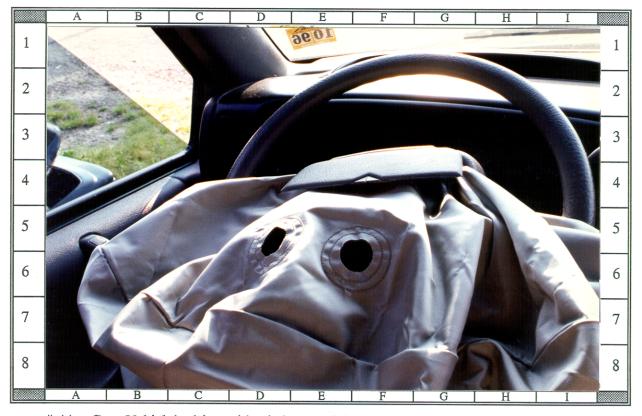
44: Case Vehicle's driver side air bag module showing air bag's vent ports, noncontacted steering wheel rim, and module's top cover flap

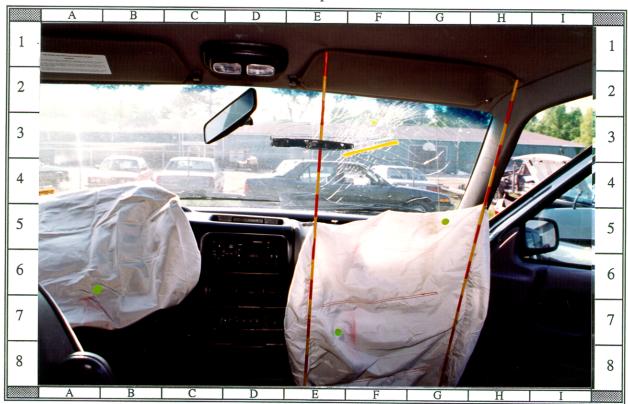
46: Case Vehicle's deployed air bags, front dash, and rearview mirror; NOTE: contacts to both air bags (green dots) and windshield (yellow tape)

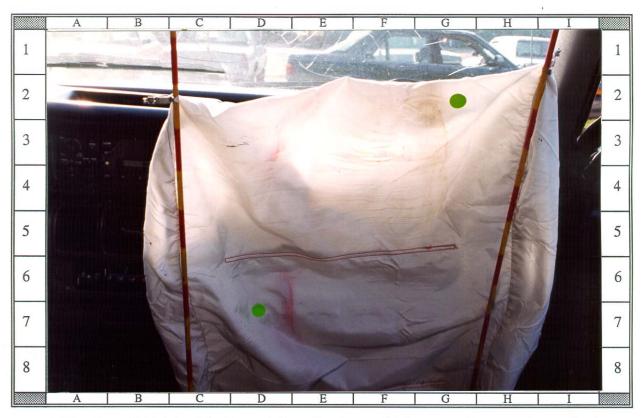
47: Case Vehicle's right front air bag showing multiple areas of contact (green dots) by right front passenger

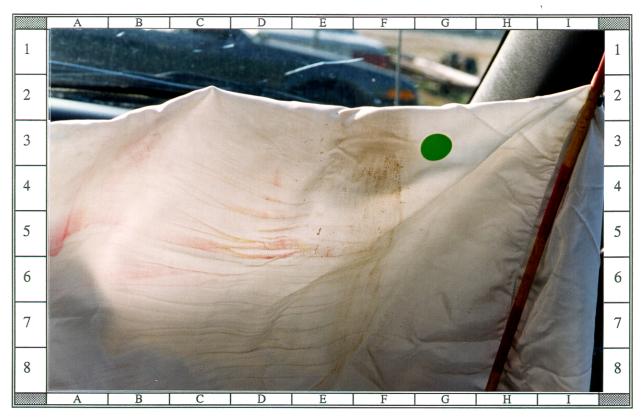
49: Close-up of contact to right upper portion of Case Vehicle's right front air bag showing a large amount of skin transfer and an unknown red smear

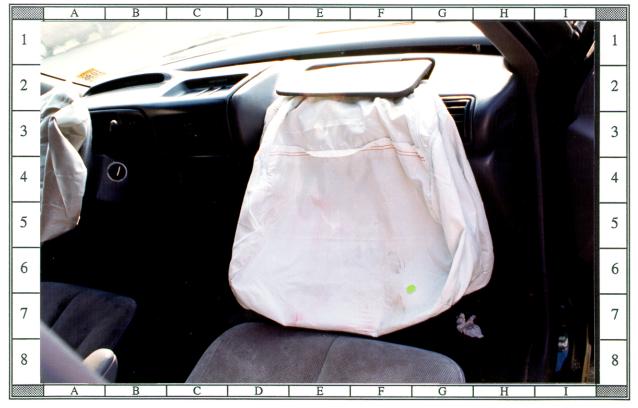
50: Top portion of Case Vehicle's right front air bag showing module's cover flap and skin and red substance smearing near right upper portion of air bag

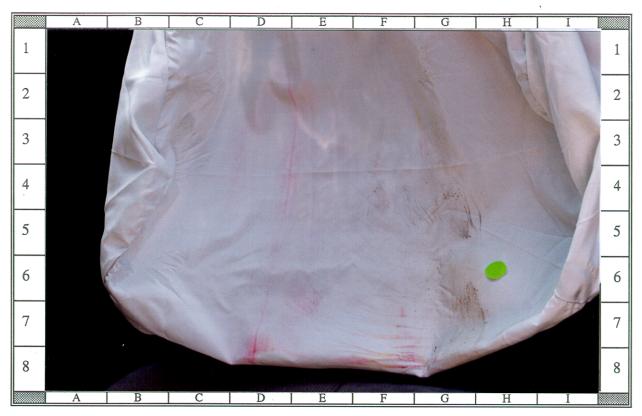
51: Close-up of contact evidence to upper portion of Case Vehicle's right front air bag; NOTE: green dot is identical to green dot shown in Photo #49 above

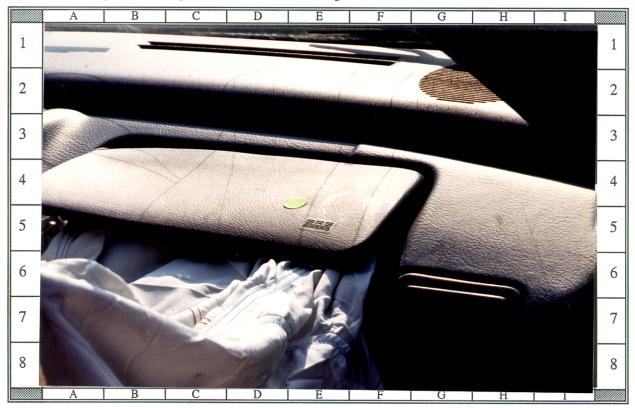
52: Close-up of cover flap from Case Vehicle's right front air bag module showing contact (oil smudge) from right front passenger's chin/neck

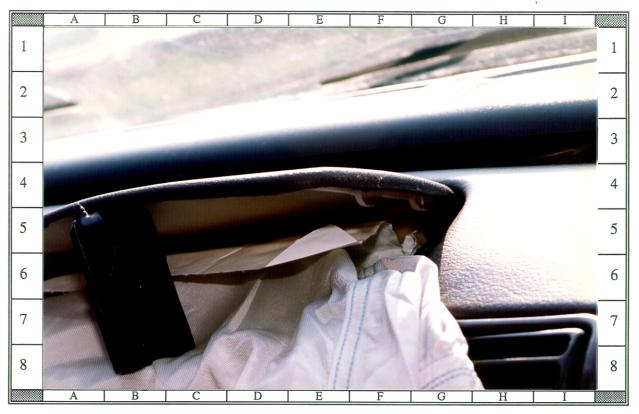
53: Close-up of cover flap's corner edge from Case Vehicle's right front air bag module showing contact evidence (skin) from passenger's neck/chin

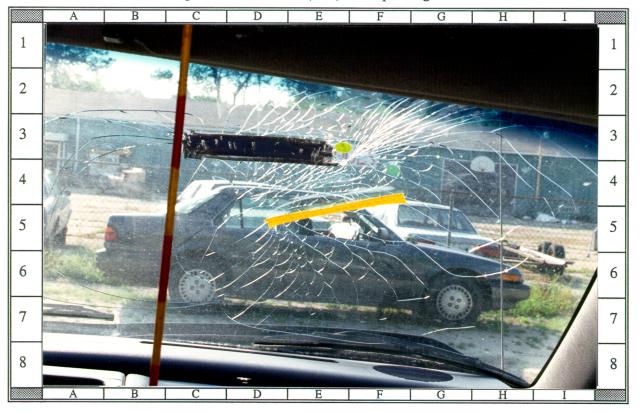
54: Case Vehicle's windshield showing evidence of contact (smear above/along yellow tape) from right front passenger's head

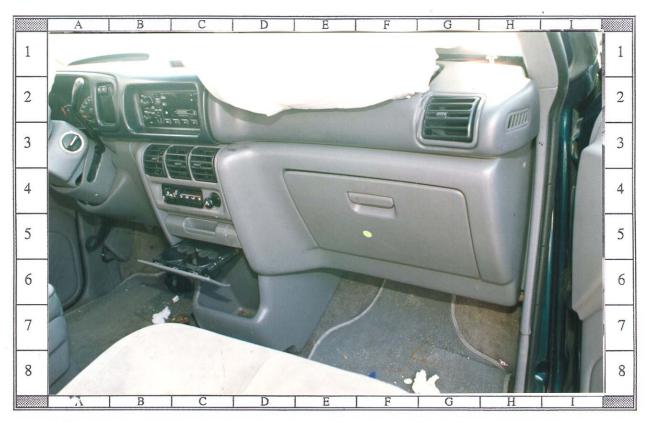
55: Case Vehicle's glovebox showing scuff mark most likely from right front passenger's lower extremities

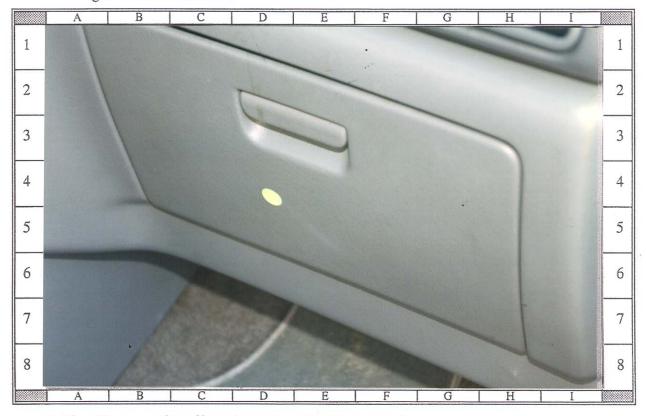
56: Close-up of scuff mark on Case Vehicle's glovebox

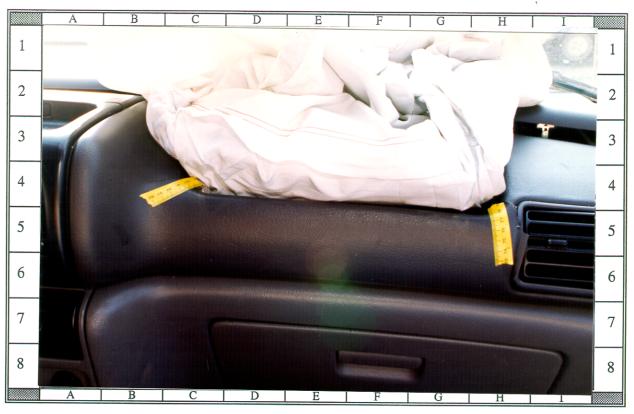
57: Case Vehicle's right dash showing tears (yellow tape) in dash which occurred during right front air bag's deployment; NOTE: separation (cell I3)

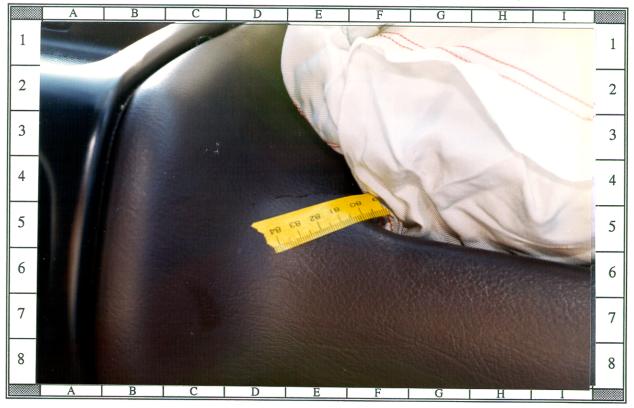
58: Close-up of tear to Case Vehicle's dash near left lower corner of right front air bag module's compartment

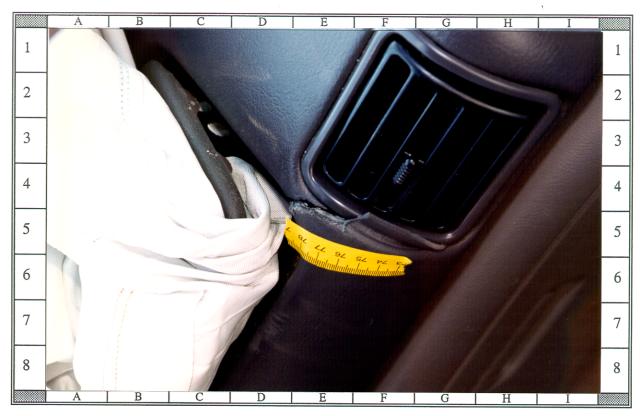
59: Close-up of tear to Case Vehicle's dash near right lower corner of right front air bag module's compartment

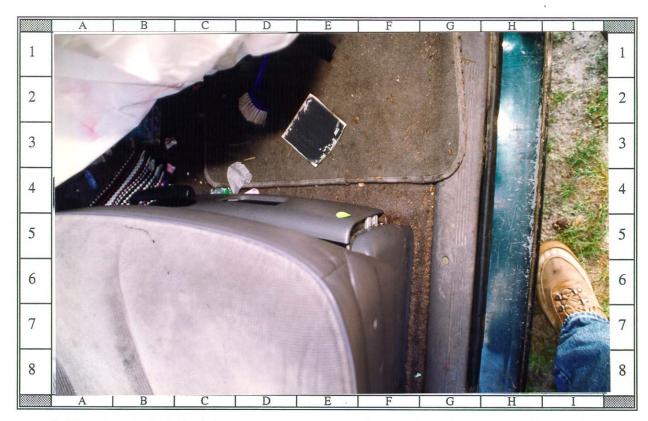
The case vehicle's subsequent impacts with the ground and sign post then sent the child forward onto the floorboard where she came to rest. The child's final rest position was confirmed by statements on her medical records and a blood spot found on the front of the auxiliary glove box located underneath the front right passenger's seat; see SELECTED PHOTOGRAPHS #61 and #62.

61: Case Vehicle's right front passenger seat showing blood spot on vertical surface (green dot) of auxiliary glovebox underneath seat

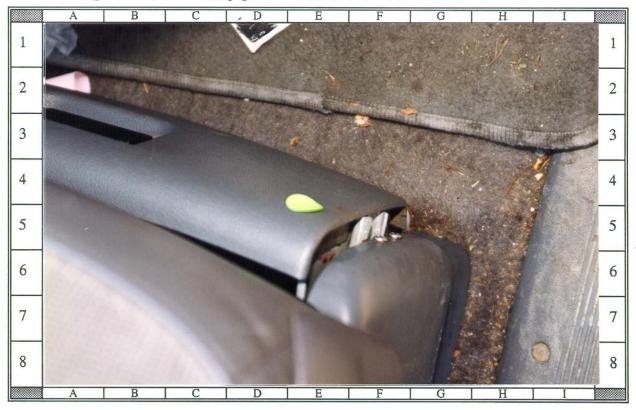
62: Close-up of blood spot on vertical surface of auxiliary glovebox underneath Case Vehicle's right front passenger seat

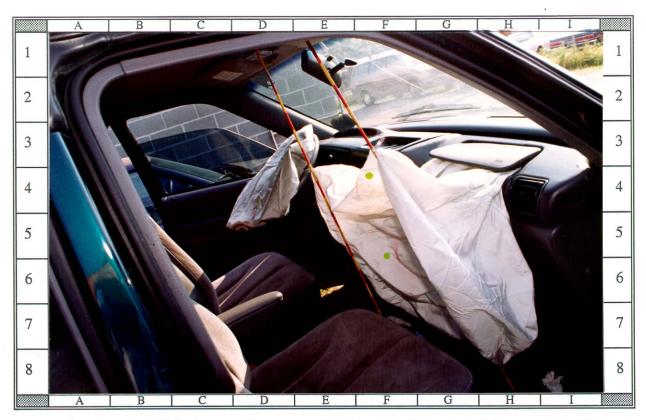
63: Case Vehicle's front seating area and deployed air bags viewed from outside right front passenger's door

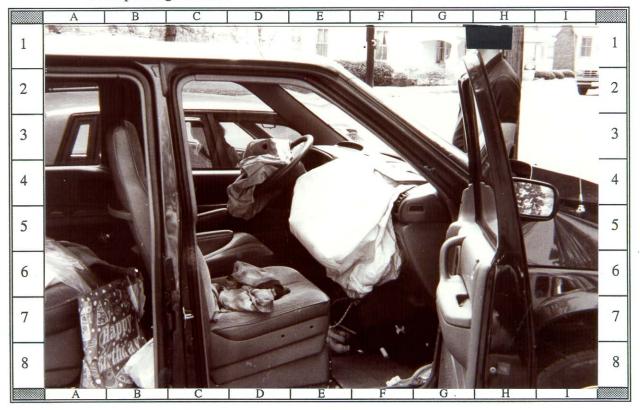
64: On-scene view of Case Vehicle's front seating area and deployed air bags viewed from outside right front passenger's door

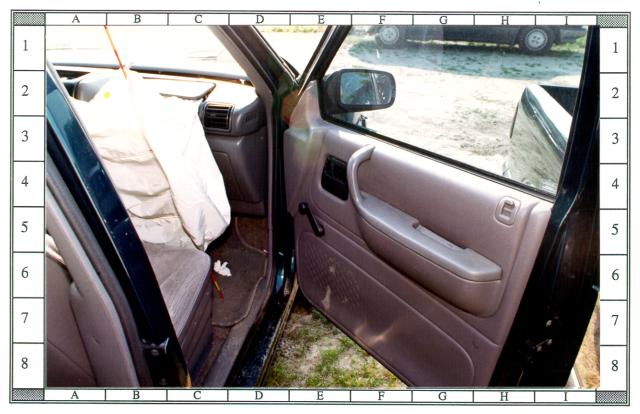
65: Interior surface of Case Vehicle's right front passenger door panel and deployed air bag; NOTE: no contact evidence to door panel

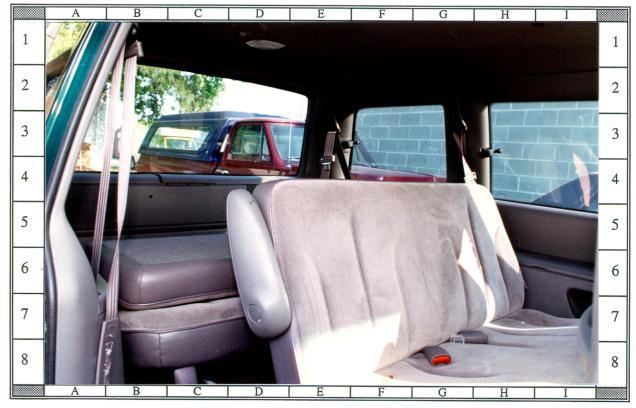
66: Case Vehicle's second seating area where two three year-olds were seated in booster seats of unknown type; NOTE: 3-point safety belts at outboard positions

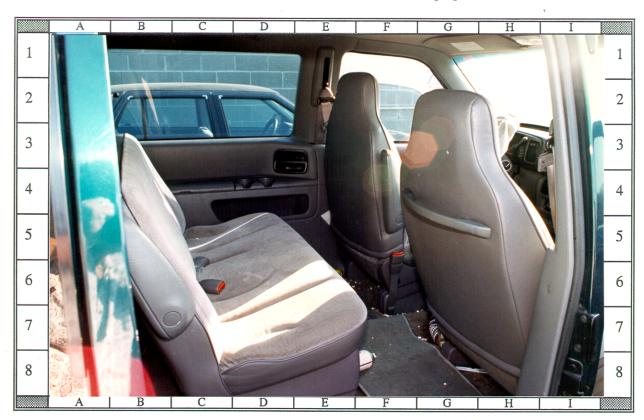
67: Case Vehicle's second seating area and front seatbacks which showed no evidence of contacts from second seat passengers

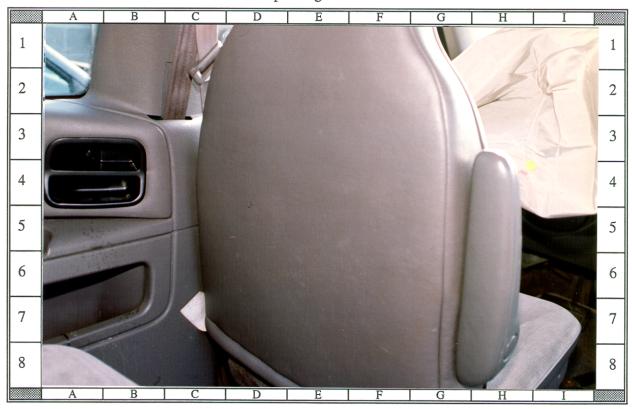
68: Close-up of Case Vehicle driver's seatback; NOTE: no evidence of contact from left second-seated passenger

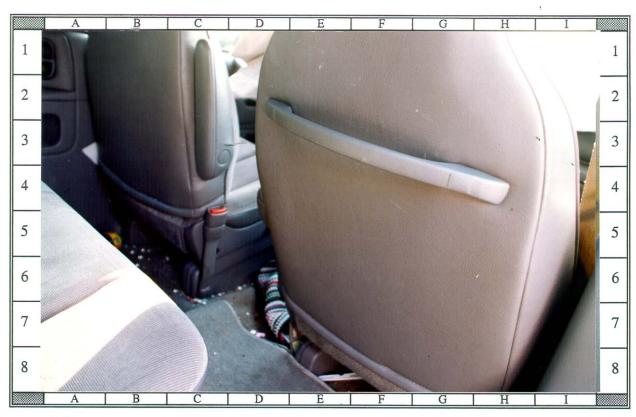
69: Close-up of Case Vehicle passenger's seatback; NOTE: no evidence of contact from right second-seated passenger

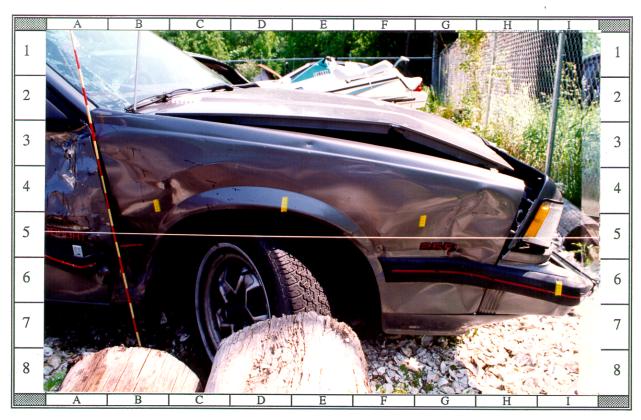
#71: Close-up of direct damage to Vehicle #2's right front fender viewed from right

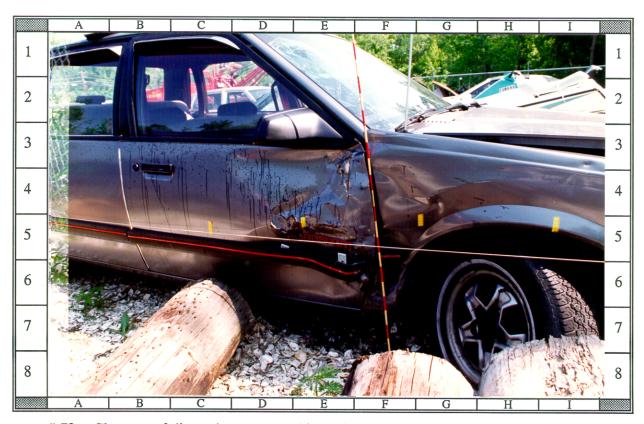
72: Close-up of direct damage to Vehicle #2's right front fender and passenger door viewed from approximately 75 degrees right of front

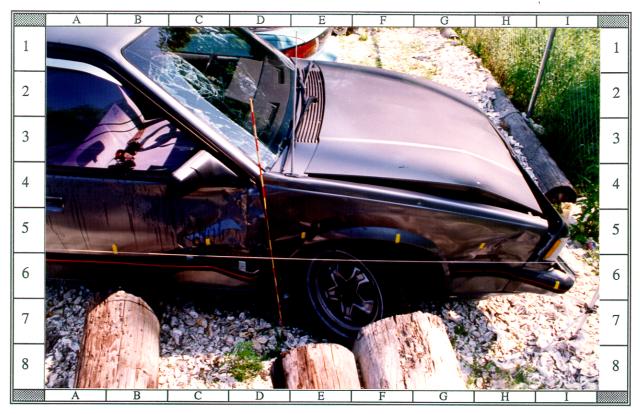
73: Right overhead view of Vehicle #2's damaged right side; NOTE: yellow tape represents C-measurements and spiderweb pattern to right windshield

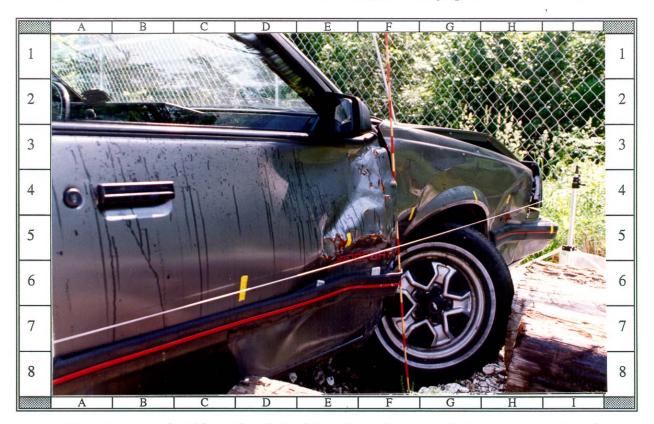
75: Close-up of Vehicle #2's right side deformation viewed from approximately 60 degrees right of back

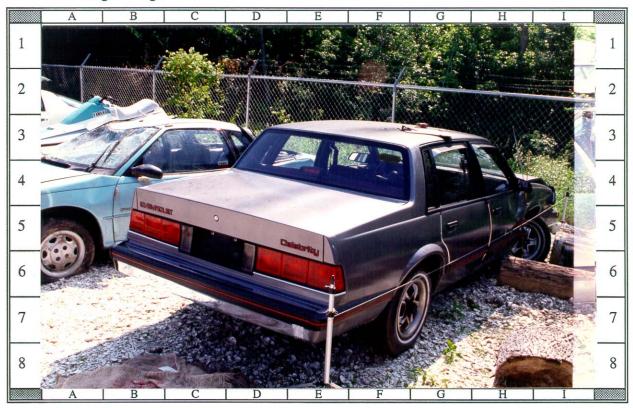
76: Vehicle #2's undamaged right back side and back viewed from approximately 45 degrees right of back

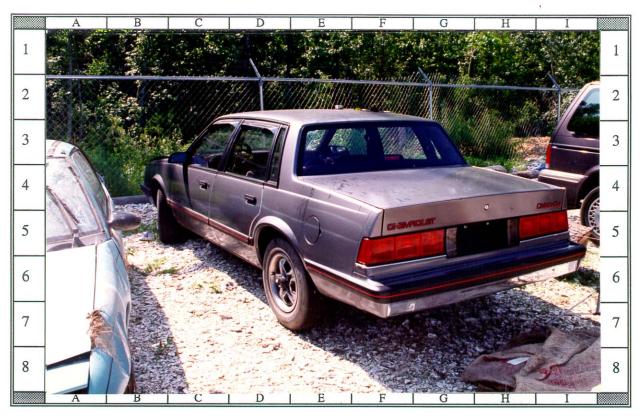
77: Vehicle #2's undamaged back and left side viewed from approximately 45 degrees left of back

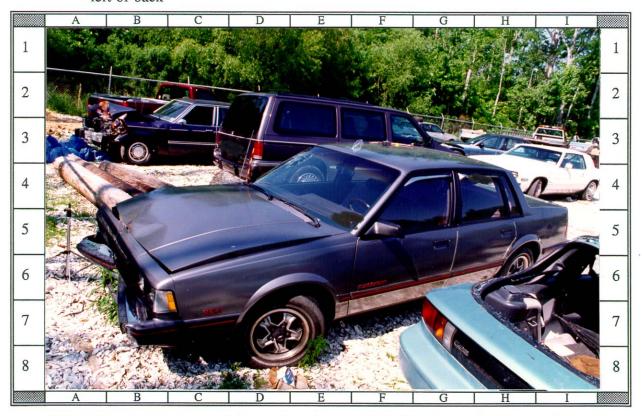
78: Vehicle #2's damaged front and undamaged left side viewed from approximately 75 degrees left of front; NOTE: frontal impact was from utility pole

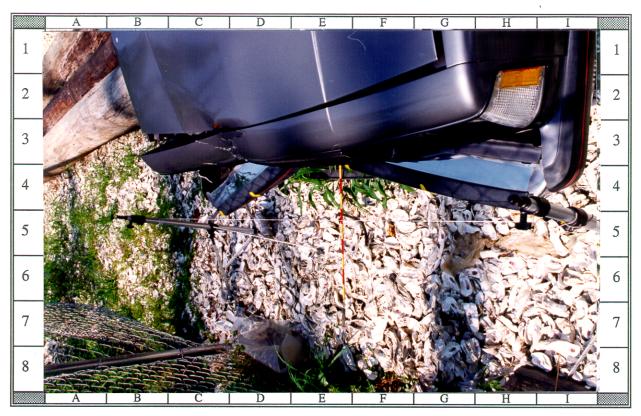
79: Reference line view of Vehicle #2's frontal damage from left; NOTE: frontal impact was from utility pole

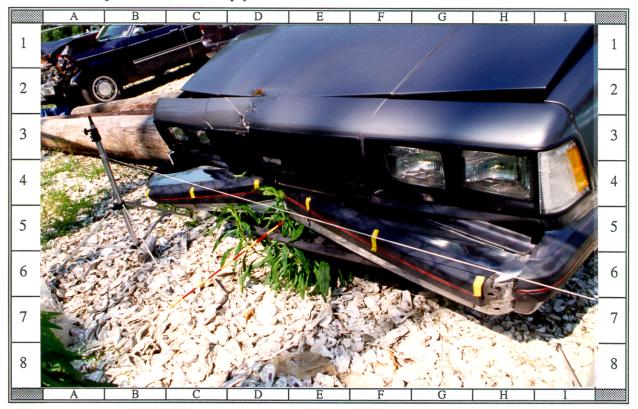
80: Close-up of Vehicle #2's frontal damage from impact with utility pole viewed from approximately 60 degrees left of front

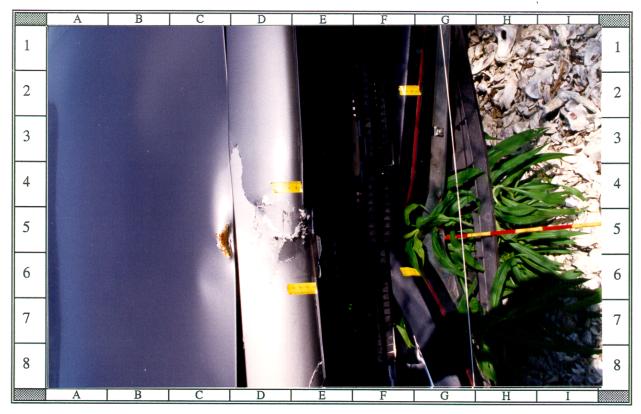
81: Close-up of Vehicle #2's direct damage from impact with utility pole; NOTE: narrow impact area

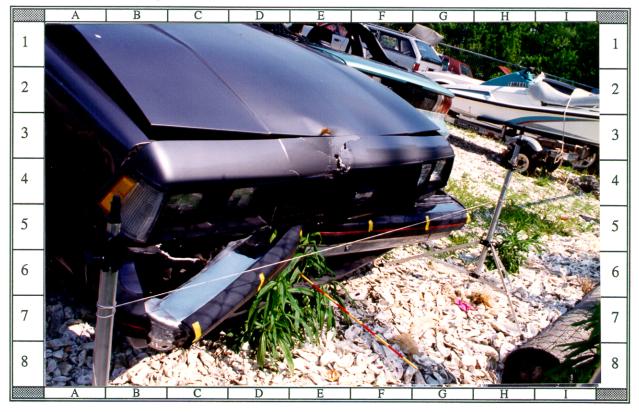
82: Close-up of Vehicle #2's frontal damage from impact with utility pole viewed from approximately 45 degrees right of front

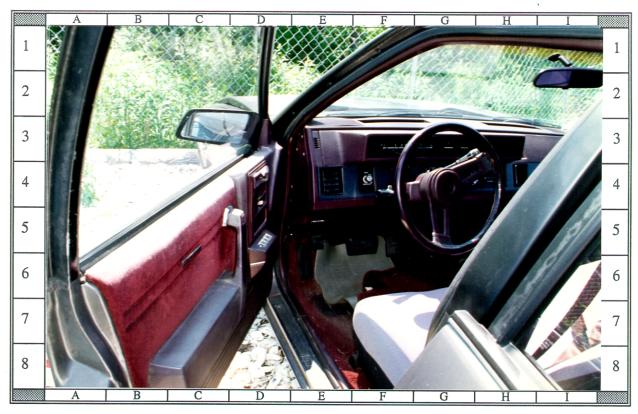
83: Interior surface of Vehicle #2's driver door panel, steering wheel, and front dash area viewed from outside driver's door; NOTE: no evidence of contact

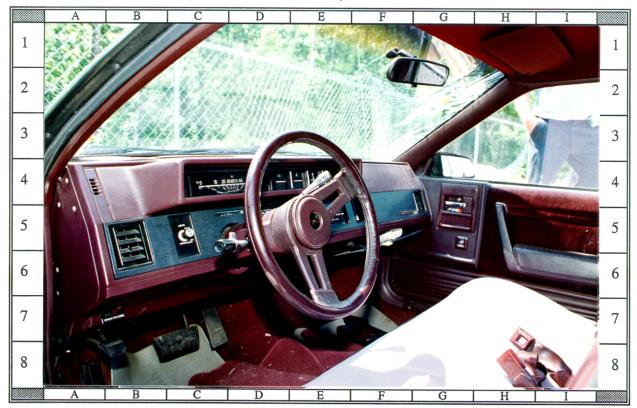
84: Vehicle #2's front seating area, steering wheel, and dash; NOTE: contacts to right side of windshield and dash from driver

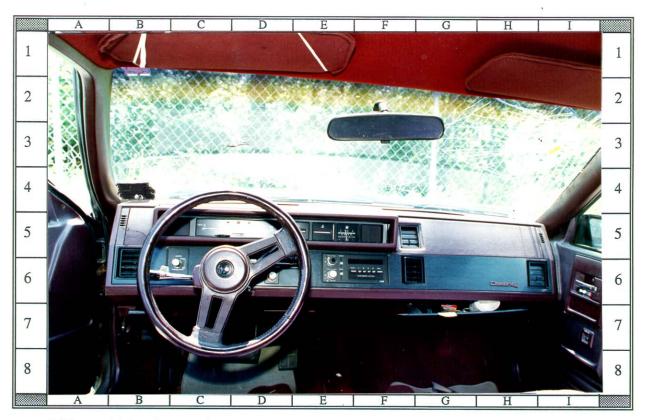
85: Vehicle #2's steering wheel, front dash, rearview mirror, windshield and header area viewed from rear center seat
